# Manhole Inspection Summary

Manhole # S21W\_\_022MH

**Location** Address: **1903 MAISEL ST**

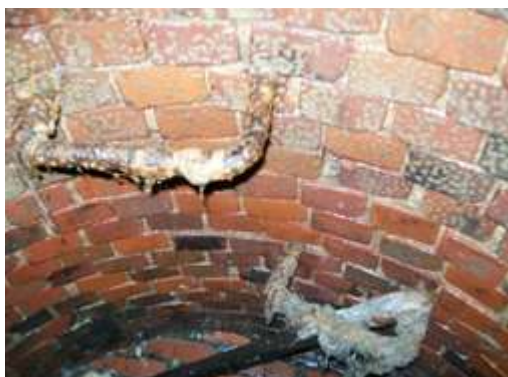
Defect 4

**Steps** Count: **7** Missing: **0** ☒ **Corroded**

**Surcharge** ☒ **Evidence Of Surcharge** Depth: **8** (ft.) ☐ Active Surcharge Present

EVIDENCE OF SURCHARGE;  
CORRODED STEPS

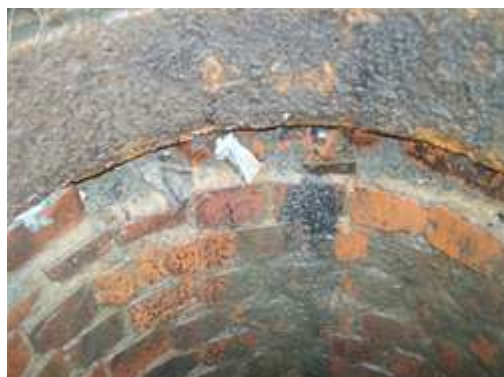
Defect 3

Condition: ☐ Sound ☐ Cracked ☐ Root Intrusion ☐ Loose Brick ☒ **Deteriorated**

DETERIORATED CHIMNEY BRICKS

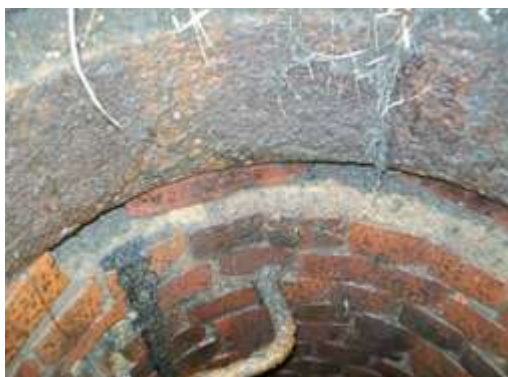
Defect 2

Infiltration: ☐ None ☒ **Joint** ☐ Cracks ☐ Mortar ☐ Roots ☐ Wall

INFILTRATION @ CHIMNEY/FRAME  
JOINT

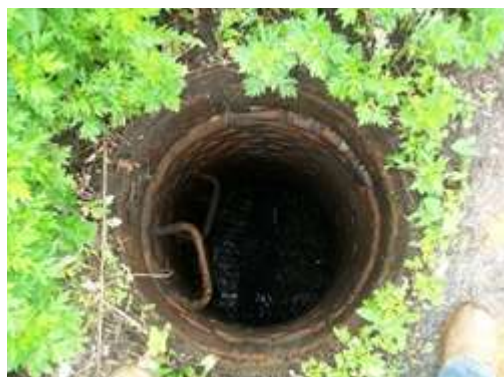
Defect 1

**Frame** Offset: **1.5** (in.) Condition: ☒ Sound ☐ Cracked ☐ Leaks

FRAME OFFSET

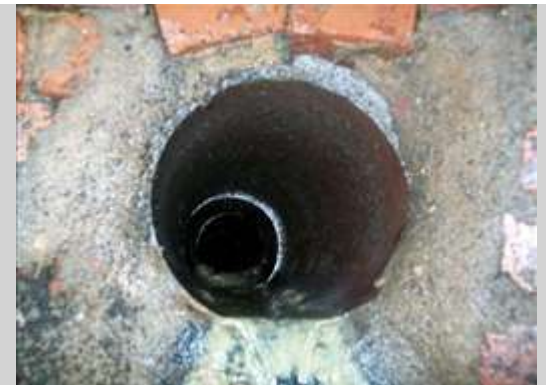
3 O'Clock Inflow

Pipe Height: **8.4** (in.) Rod and Bar (Angled)  
Pipe Material: **Clay** ☐ Pipe Lined  
Invert Depth: **11.50** (ft.) Flow Characteristics: **Slow**  
Deposits: ☐ None ☐ Mud ☒ Sludge ☒ Debris ☐ Grease  
Silt Depth: **5** (in.) Deposits Extent: **Heavy**  
Infiltration: **None** Pipe Seal Cond: **Unknown**

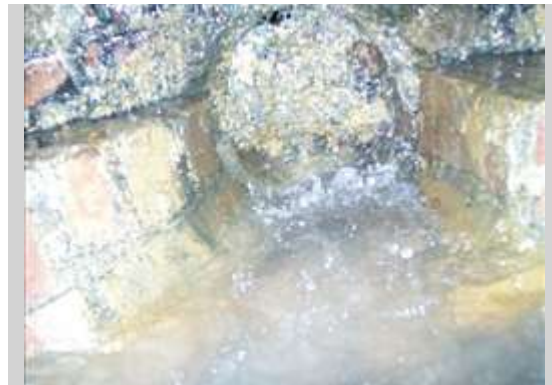
Drop In @ 3 O'Clock

Drop: **Outside** Rod and Bar  
Angled: **Yes** Reading: **12.85** (ft.)  
Inv Depth: **13.85** (ft.)  
Drop Condition: **Clogged**

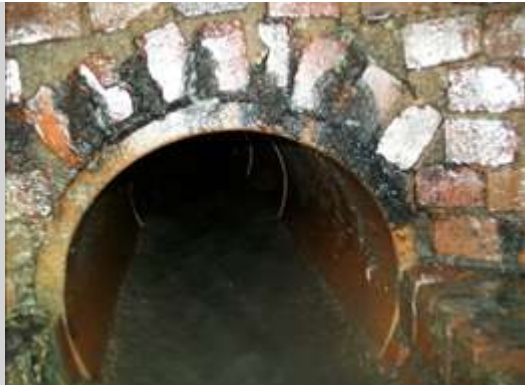
5 O'Clock Inflow

Infiltration: **Weeper** Pipe Seal Cond: **Sound**
